# Air Conditioning Modifications for the GMC RTSII Series 01 Coach (Model TH-8201)

Prepared by:  
Transportation Systems Center  
Urban Systems Division

October 1982  
Final Report

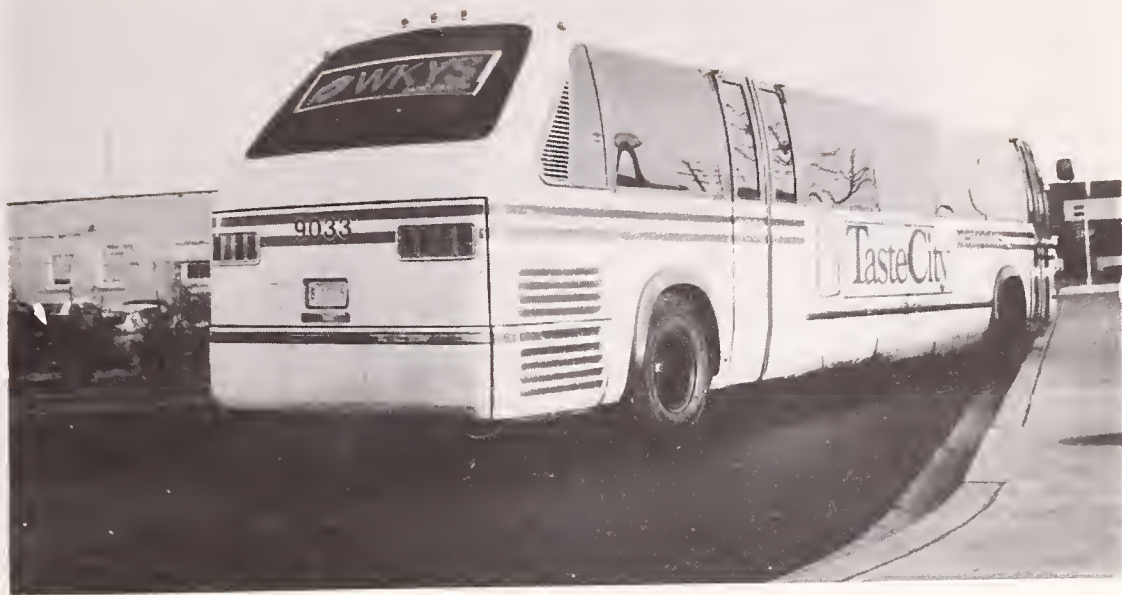
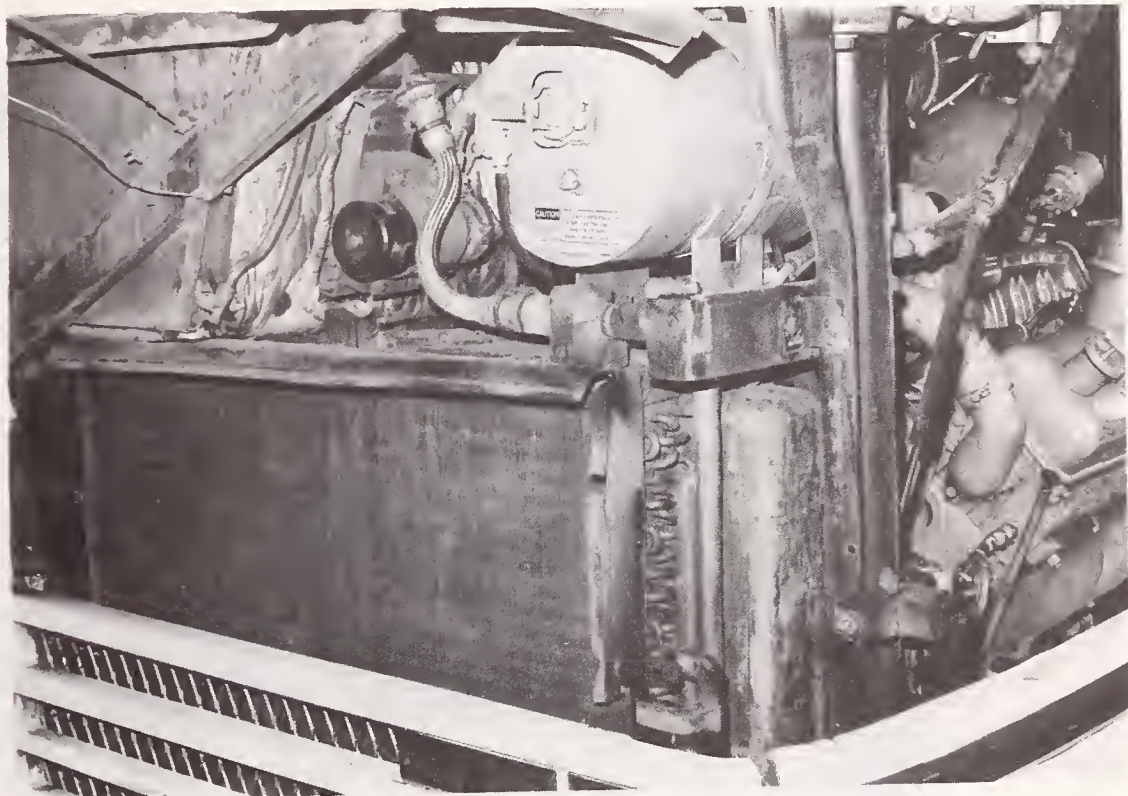
**FIGURE 1**

**Unmodified RTS II Series 01 Coach**
